MINE SAFETY INVESTIGATION UNIT

INFORMATION RELEASE

High risk incident

| Event | Unplanned ejection of 18 drill pipes from a gas well |

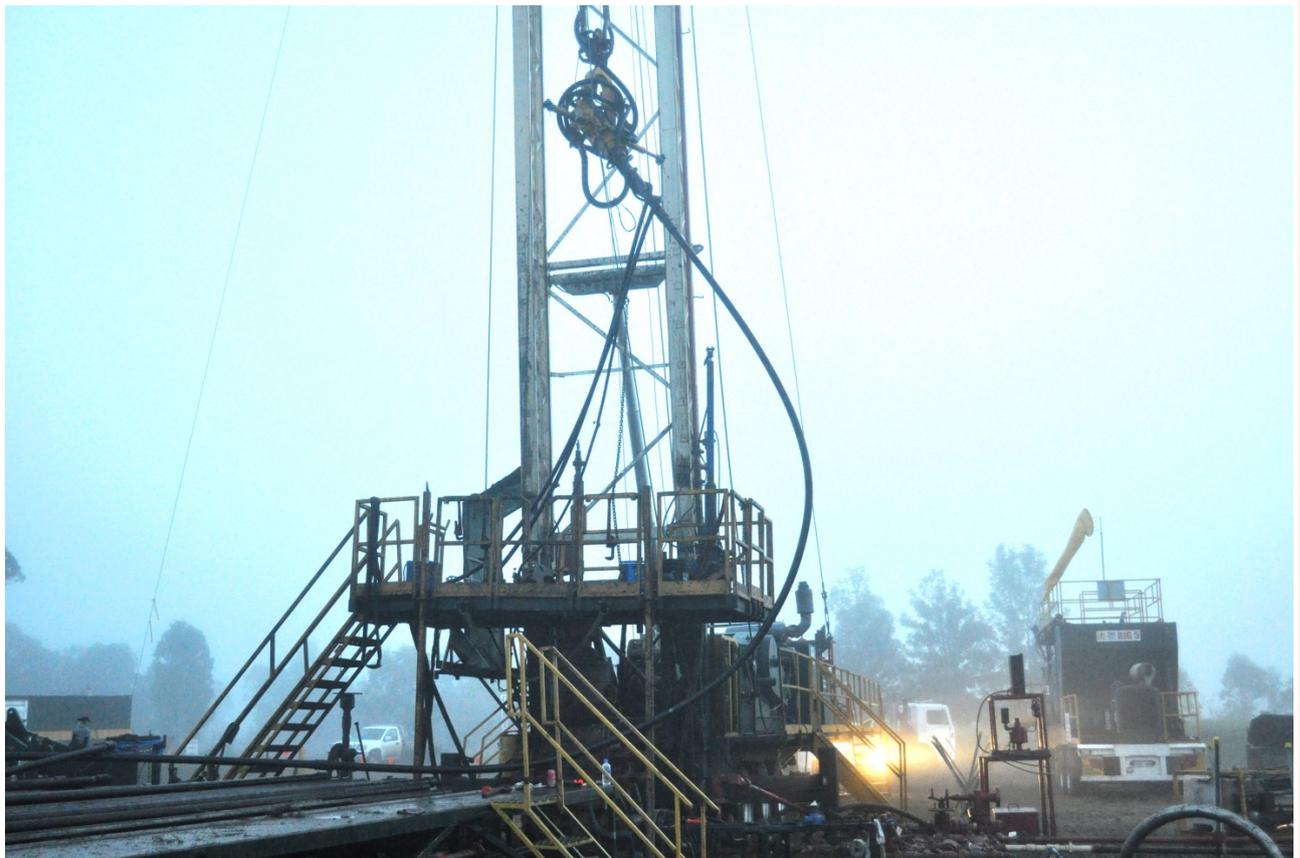
The workover rig showing the swivel and a portion of the ejected pipe *Photograph supplied by Metgasco*

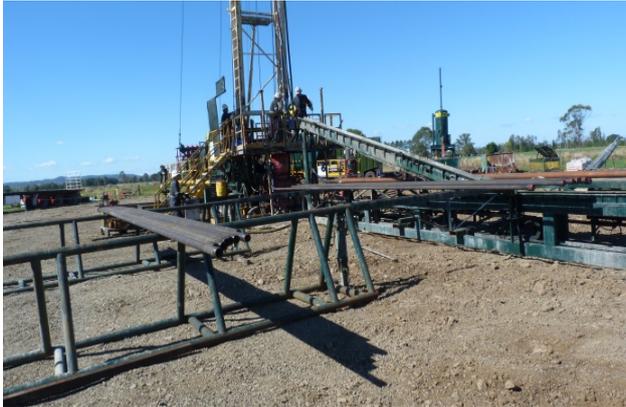
The workover rig

Photo depicts the rig from the Kingfisher incident after it has been redeployed to its next job.

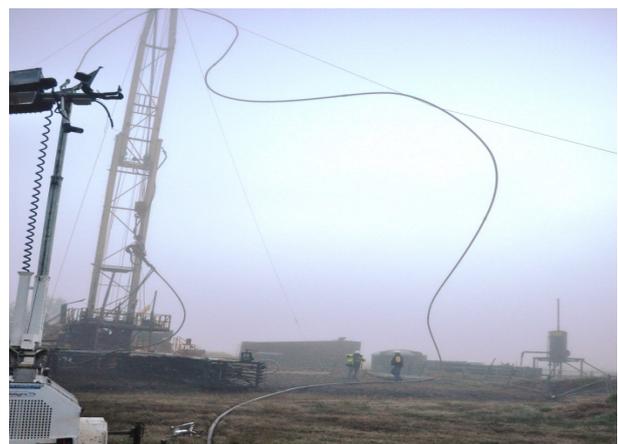
Suspended drill string

Some of the drill string still suspended mid-air after the event.

Note: the lighting tower in the foreground had some lights torn off by the falling pipes, some of which can be seen lying on the ground.

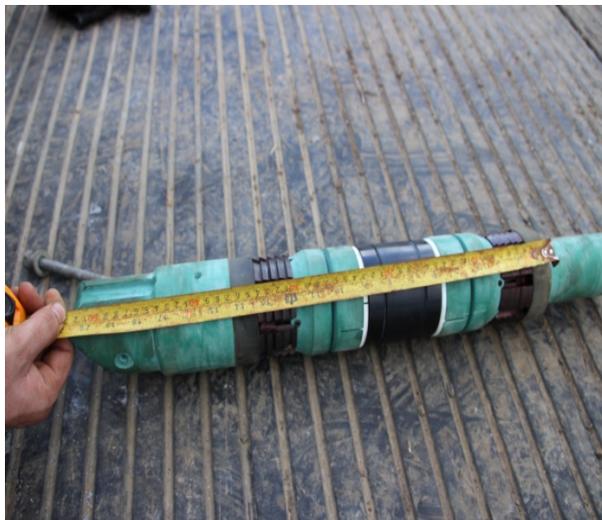
Bridge plug

The bridge plug was installed 200 m down from the surface. The rationale for selecting this relatively shallow depth was, in part, the thought that the production casing integrity problems were likely to be below the bridge plug. The well head work was completed and the crew set up to mill out the bridge plug not expecting that the gas pressure had built up beneath the plug.

A bridge plug similar to that used in the Kingfisher well. Its purpose is to seal the bore casing at a predetermined depth to isolate any pressure or fluid generated below the plug. It can be drilled out or milled when it is no longer needed.

Where bridge plugs are used, and are to be drilled through, measures to control the risk of encountering well pressure should be identified and implemented.

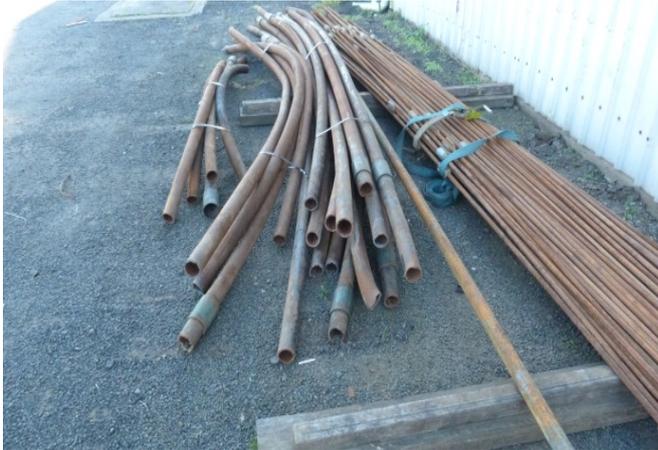
Drill pipes

A bundle of regathered drill pipes damaged during the incident.

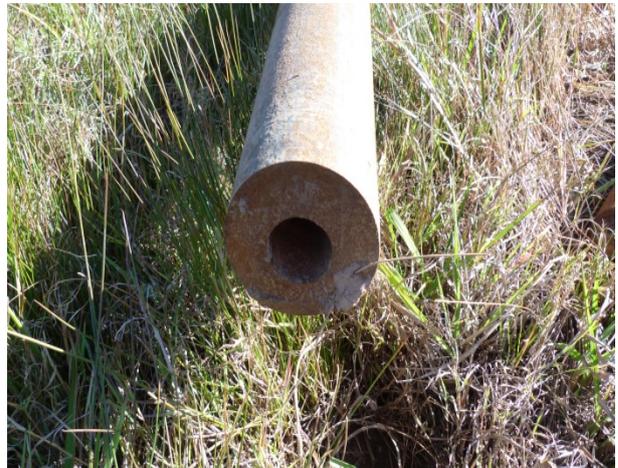
Drill collars
The four lowermost segments of the drill string were of far heavier construction. These 'drill collars' are intended to provide weight to the drill string. In this case four collars were insufficient to defeat the pressures encountered in the well.

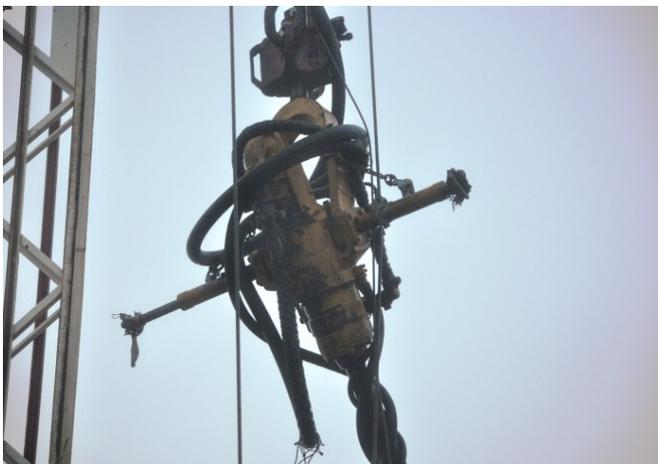
Swivel

The swivel located at the top of the drill string was also damaged.

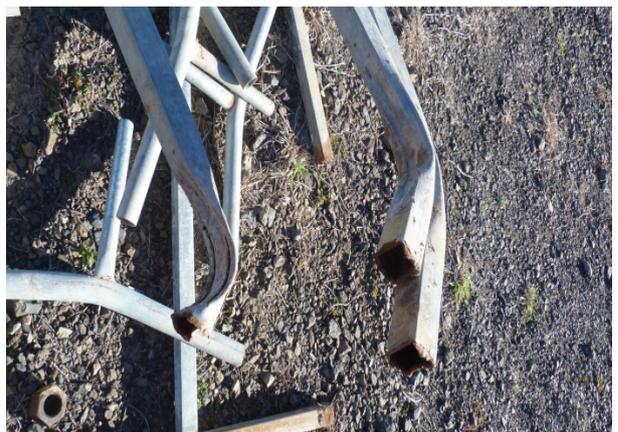
Collateral damage
These pipes are remnants of a fence that was in the path of the falling drill string components. They provide an illustration of the destructive forces at work.
